Manhole Inspection Summary

Manhole # S43K__027MH

Insp Date: **6/4/08 8:36 AM**

Location Address: **side of 1525 dallas st**

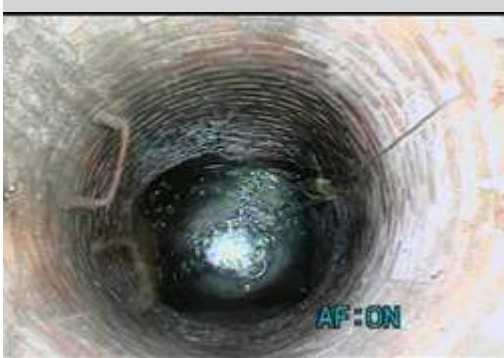
Defect 1

Count: **12** Missing: **10** ☒ Corroded

☒ Evidence Of Surcharge

Depth: **10** (ft.)

missing/corroded steps, surcharge
evidence

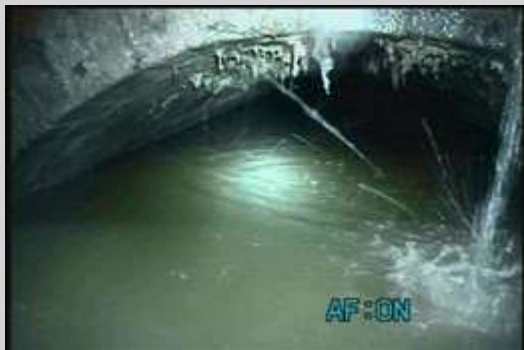
12 O'Clock Outflow

42 in. Circular Gravity Sewer
Pipe Out @ 12 O'Clock

Pipe Material: **Clay** ☐ Pipe Lined

Invert Depth: **13.00** (ft.) Flow Characteristics: **Fast**

Infiltration: **None** Pipe Seal Cond: **Unknown**

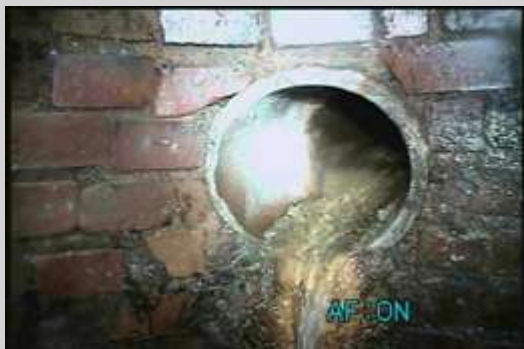
3 O'Clock Inflow

12 in. Circular Gravity Sewer
Pipe In @ 3 O'Clock

Pipe Material: **Clay** ☐ Pipe Lined

Invert Depth: **10.10** (ft.) Flow Characteristics: **Fast**

Infiltration: **None** Pipe Seal Cond: **Unknown**

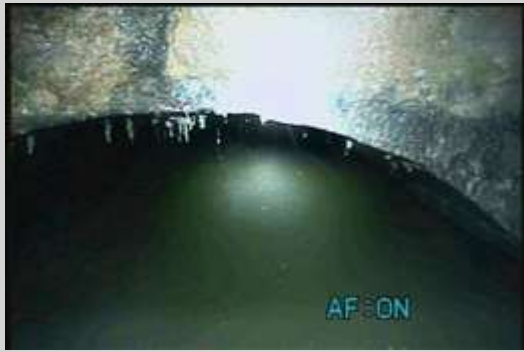
6 O'Clock Inflow

42 in. Circular Gravity Sewer

Pipe In @ 6 O'Clock

Pipe Material: **Clay** ☐ Pipe Lined

Invert Depth: **12.80** (ft.) Flow Characteristics: **Fast**

Infiltration: **None** Pipe Seal Cond: **Unknown**

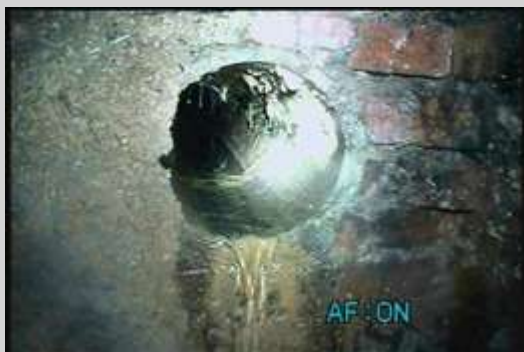
9 O'Clock Inflow

8 in. Circular Gravity Sewer

Pipe In @ 9 O'Clock

Pipe Material: **Clay** ☐ Pipe Lined

Invert Depth: **11.50** (ft.) Flow Characteristics: **Fast**

Infiltration: **None** Pipe Seal Cond: **Unknown**
